AEROSPACE REPORT NO.  
TR-93(3478)-1

## Investigation of ACC/CCI Tunnel Diodes

1 November 1993

THE AEROSPACE  
CORPORATION  
El Segundo, California

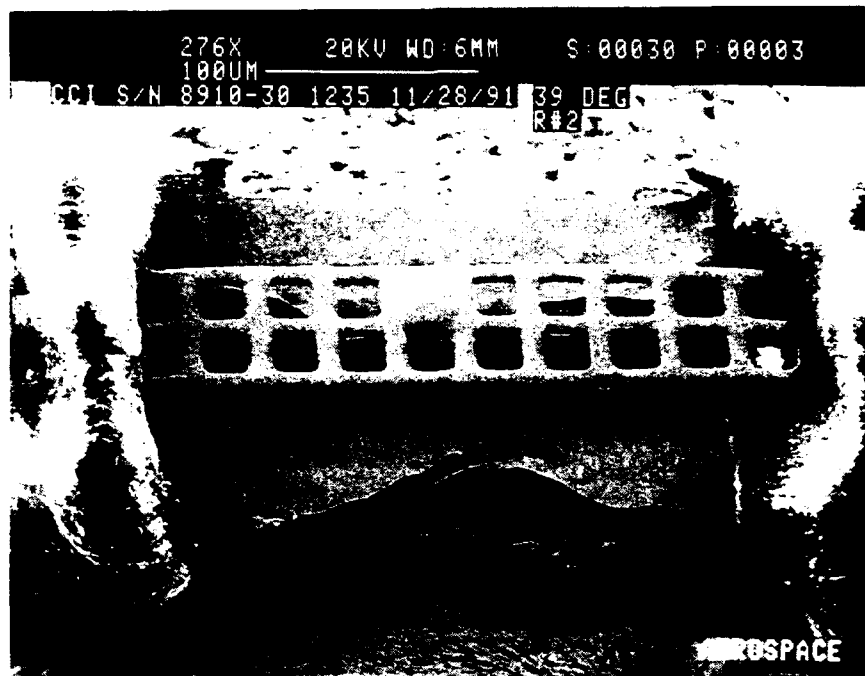
The germanium die appeared to have sustained some damage during fabrication, possibly as a result of rough handling with tweezers. One side of the die does not have a straight edge, but instead shows a deep indentation (Figure 5). The indented region does not have sharp edges, and indeed subsequent etching by potassium hydroxide could well have smoothed any projections. The critical mesa region is well away from the indentation, and the condition of the die along the edges shouldn't affect performance.

Figure 5. Overall appearance of the die (DMSP device, LDC 8910, S/N 30, 276 $\times$  magnification). The nearer side has apparently been chipped. The overexposed features at the edges of the image are the insulating epoxy posts, which are charging in the SEM beam. The contact ribbon runs between the posts near the center of the image. The diode mesa is beneath the filled mesh near image center.

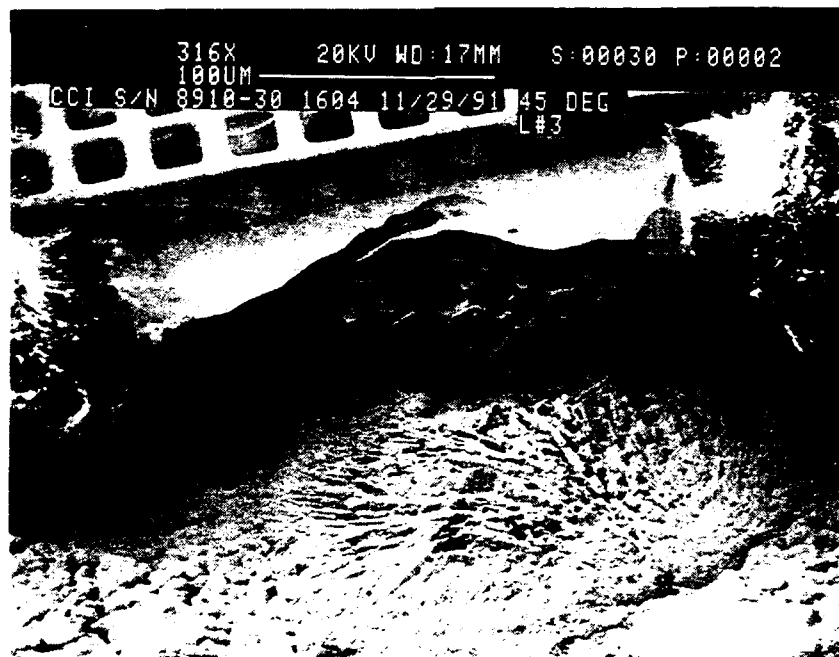
The integrity of the die attach is open to question. Cavities are visible beneath the germanium. Gold/tin solder is essentially visible only as a blob located on one side of the die. The solder in the blob has a distinct texture, with ridges radiating from a point (Figure 6). The pattern might have been formed by sliding of the chip on melted solder or may be a splash pattern. This apparent splash pattern suggests that the solder may not have been hot enough to bond to the chip.

Figure 6. Higher magnification view of bottom right area of Fig. 5 (DSMP device, LDC 8910, S/N 30, 316 $\times$  magnification). The fan (or sea-shell) shaped region in the right foreground is the Au/Sn die attach. Optically, the silver-colored solder stands out clearly against the gold. The die may not be firmly soldered to the substrate.

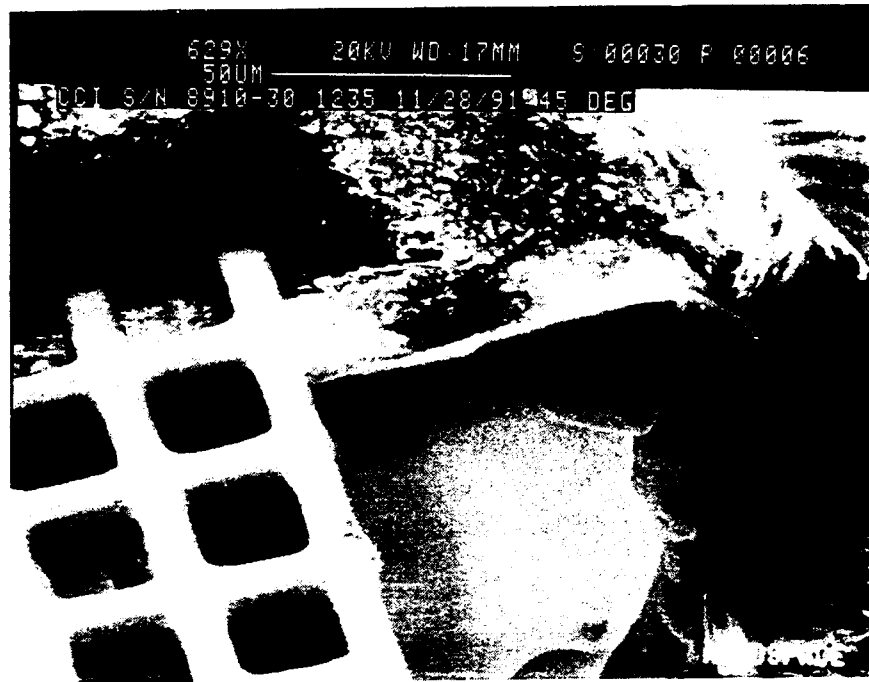
Epoxy resin is smeared up over the edges of the die during fabrication. The epoxy secures the mesh ribbon to the contact posts, and the presence of some epoxy on the die is expected. After etching of the Ge, thin, tapering ridges of epoxy are left along the sides of the die adjacent to the posts (Figure 7). There is evidence that epoxy might have spread beneath the die (Figure 8). There is a thin strip of material, apparently epoxy, under the die. This material can be seen to join continuously with the epoxy posts. Epoxy beneath the die could degrade the electrical contact between the chip and the substrate. However, the epoxy might have spread only along an edge of the die and may not be a significant concern.

Figure 7. Epoxy post (top) is bright because of charging (DSMP device, LDC 8910, S/N 30, 629 $\times$  magnification). The contact ribbon is at the left, Ge die is in right foreground. Etching of Ge die has left a permanent shoulder of epoxy.

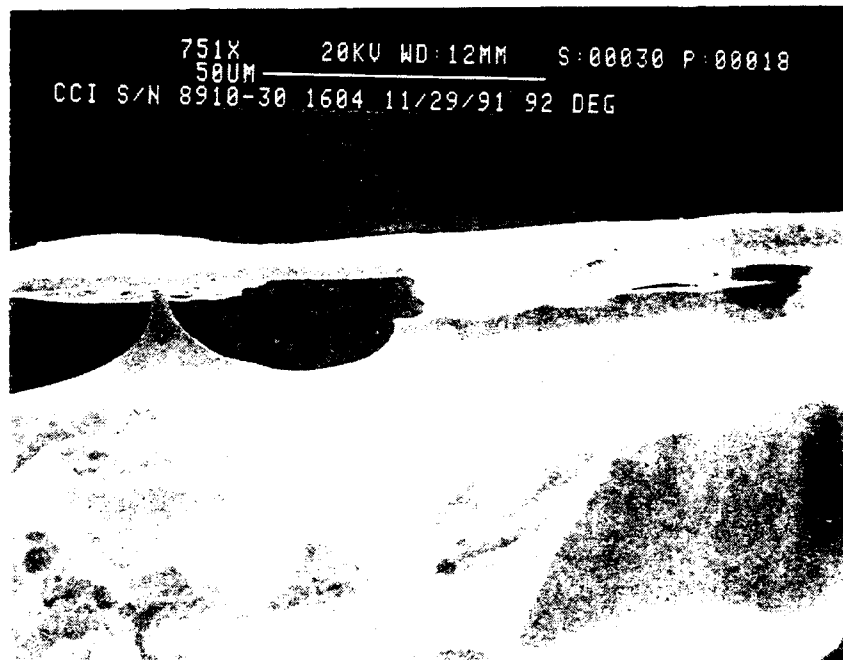
The most alarming observations are those showing excess epoxy resin on and under the mesh strap used to make electrical contact to the alloy ball. The electron micrograph of Figure 9 was obtained by tilting the specimen to view beneath the ribbon. The thin "mesa" is visible at the left. The lighter material near the right center of the image is residual epoxy resin on the bottom of the contact ribbon. Figure 10 shows a closer view of some "stringers" of epoxy that extend from the die to the ribbon. Steroscopic views are particularly graphic.

Figure 9. The bottom of the ribbon mesh (DSMP device, LDC 8910, S/N 30, 751 $\times$  magnification). The mesa is at the left. Epoxy contamination is visible (light area) toward the right.

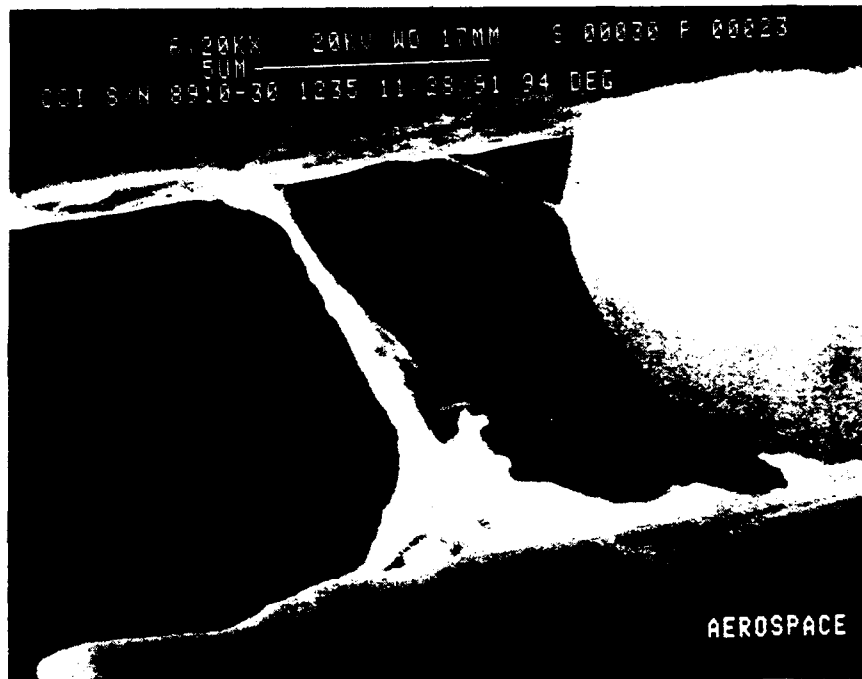
Figure 10. Closer view of epoxy contamination beneath ribbon mesh (DSMP device, LDC 8910, S/N 30, 6200× magnification). A "stringer" is at the center, a larger glob of epoxy with a small stringer at the right.

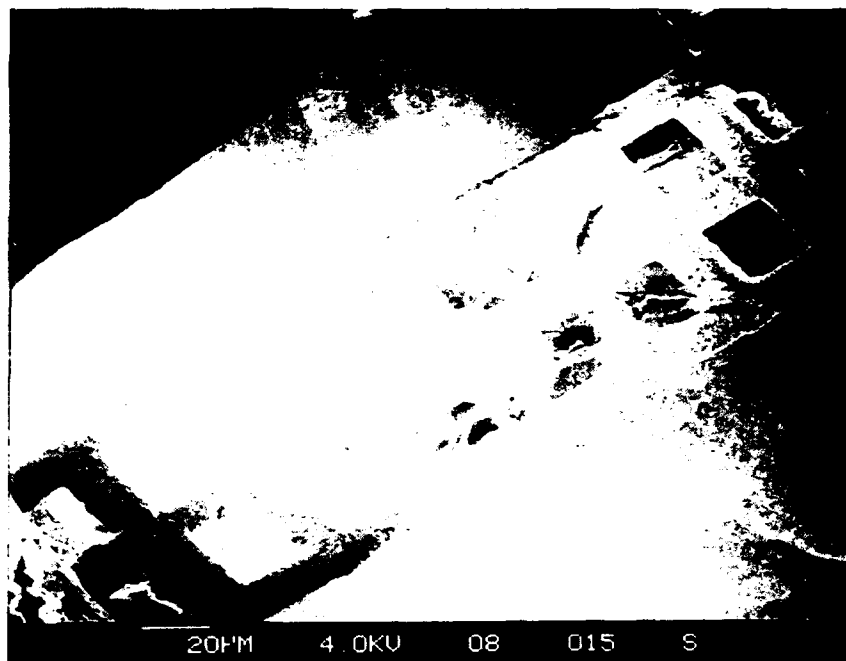
Figure 13a. Electron micrograph showing contamination of ribbon (NASA device, S/N 108, 475 $\times$  magnification). Epoxy stringers are evident in center holes in ribbon mesh.

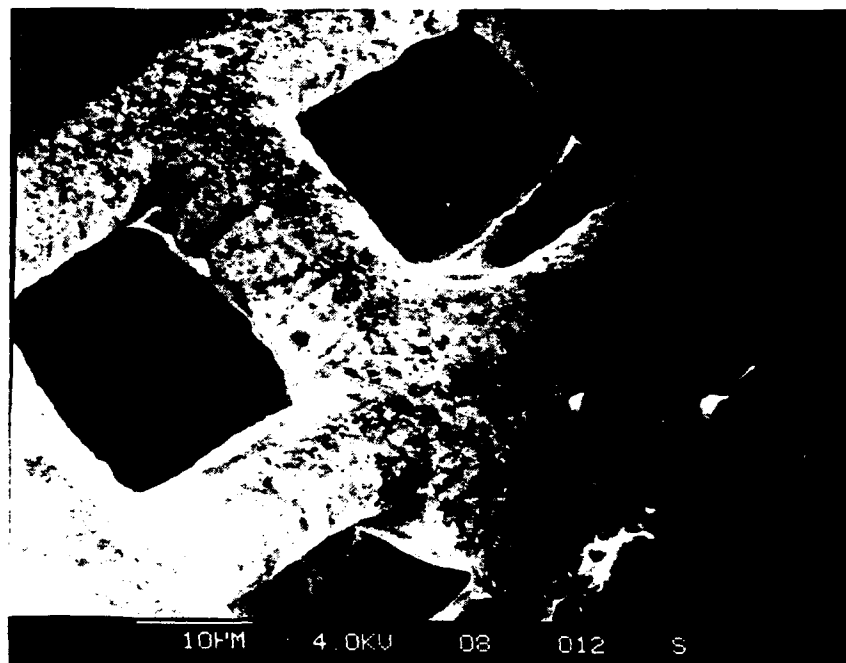
Figure 13b. Electron micrograph showing ribbon at higher magnification showing epoxy stringers more clearly (NASA device, S/N 108, 650 $\times$  magnification).

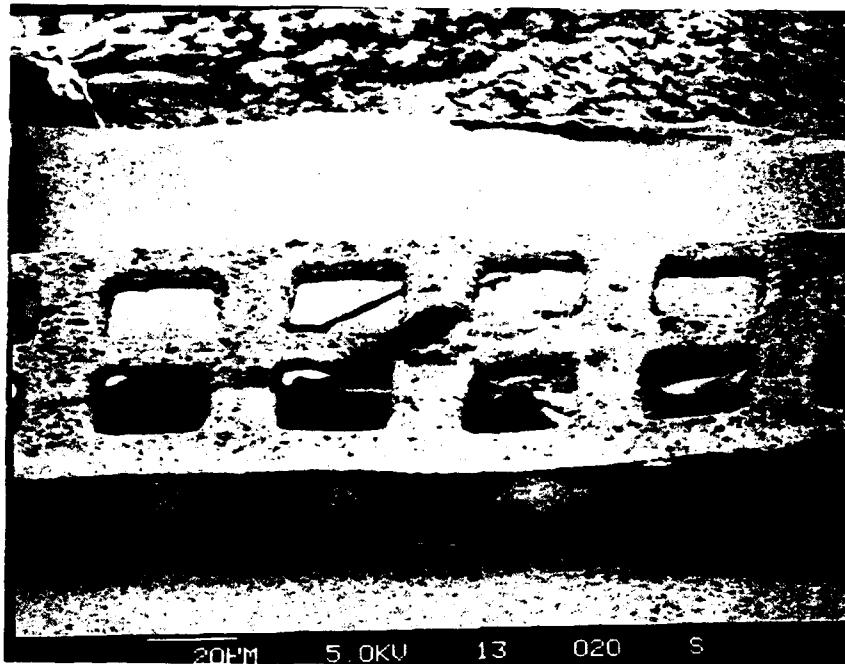
Figure 14a. Epoxy contamination appears as both dark areas on top of mesh ribbon and as bright areas (because of effects of charging) on sides and beneath ribbon (NASA device, S/N 113, 600 $\times$  magnification).

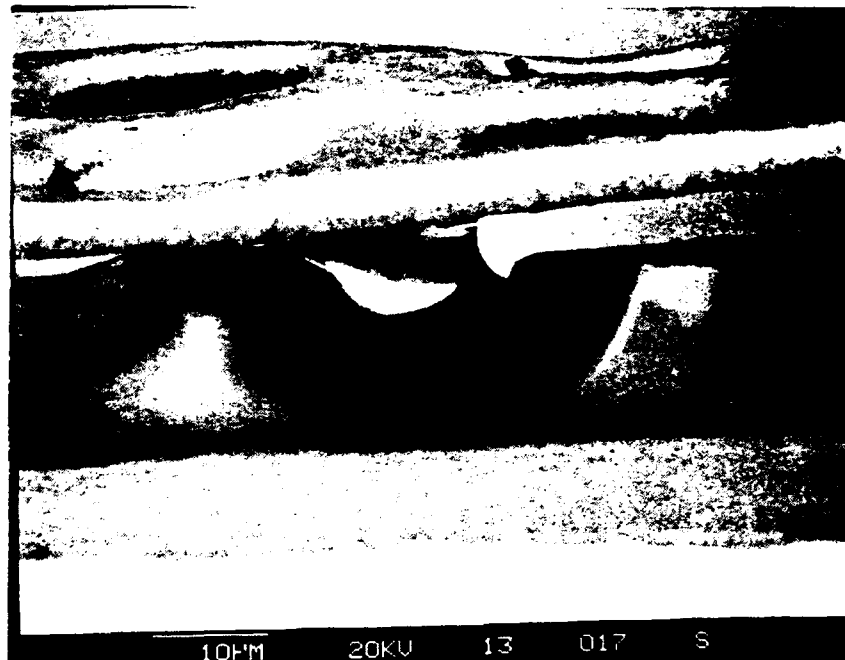
Figure 14b. Epoxy contamination around mesa (NASA device, S/N 113, 1600 $\times$  magnification). Note that the characteristic sharp edges associated with Ge appear rounded because of epoxy coating. Bright area at center is epoxy charging under beam.

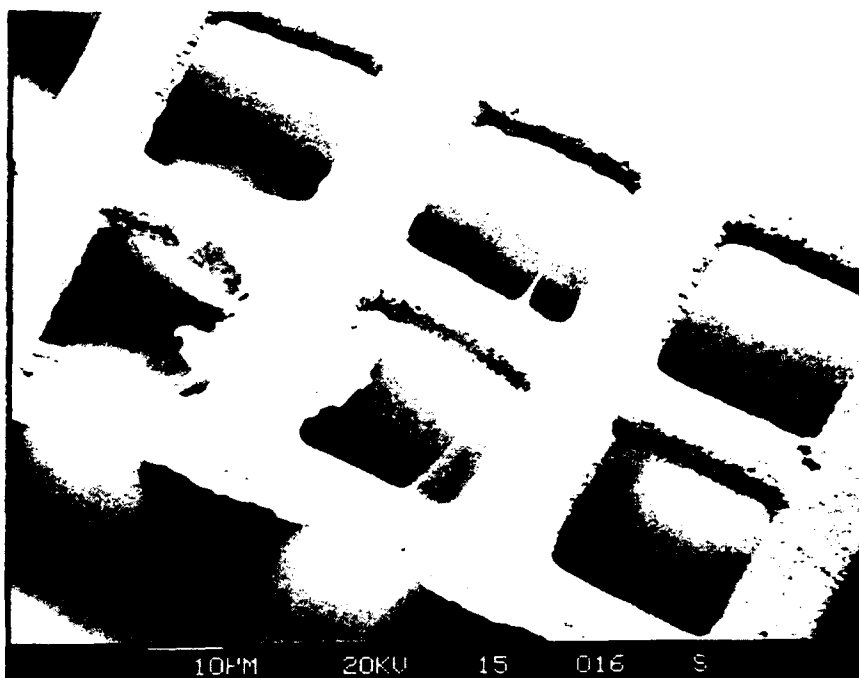
Figure 15a. Epoxy contamination. Note stringers in mesh openings near center of image (NASA device, S/N 115, 1100 $\times$  magnification).

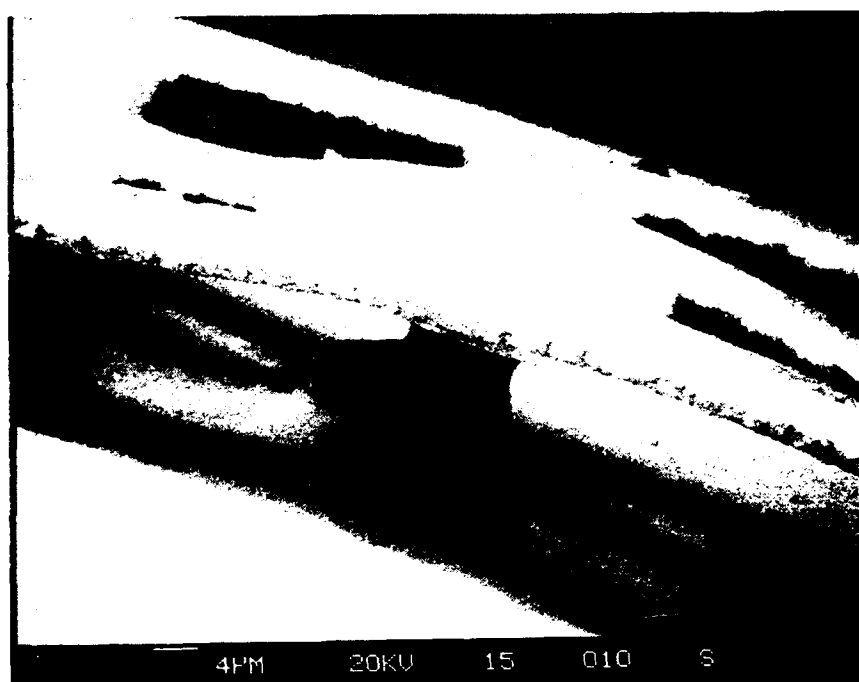
Figure 15b. Mesa in this device is not contaminated (NASA device, S/N 115, 1750 $\times$  magnification).

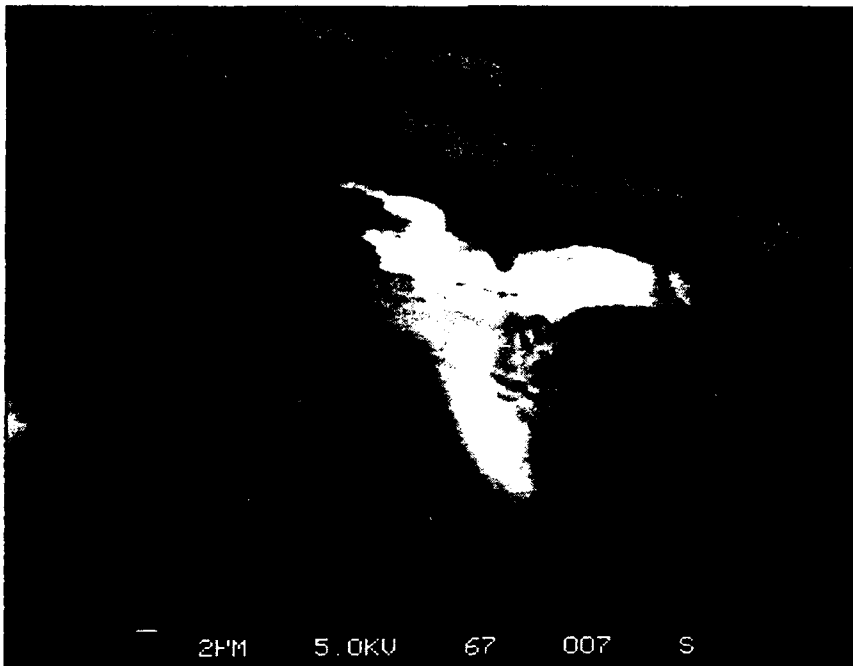
Figure 16b. Note complete coating of the mesa by epoxy (NASA device, S/N 167, 1000× magnification).

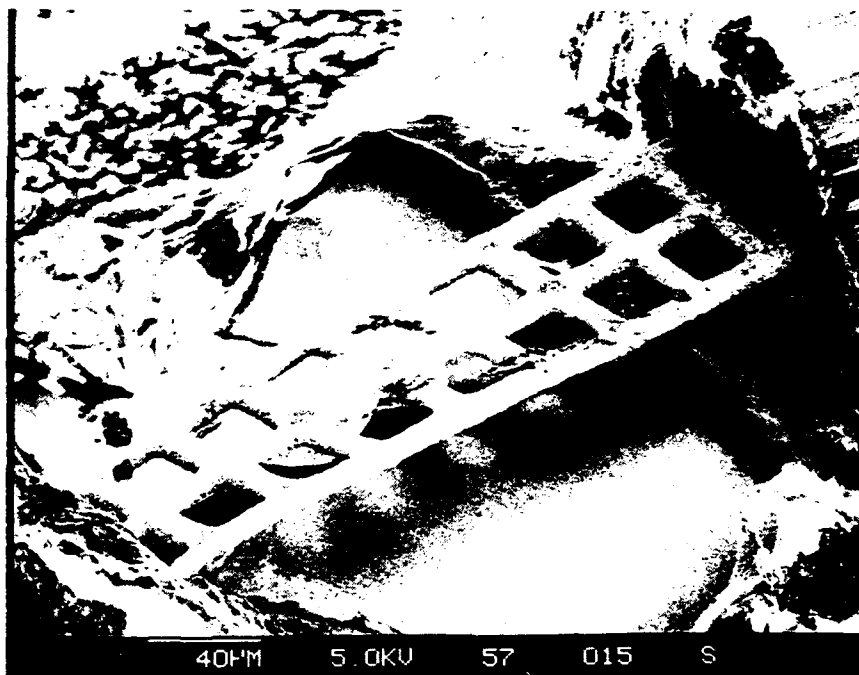
Figure 17a. Some epoxy contamination is evident on the ribbon (darker areas) (NASA device, S/N 157, 400× magnification).

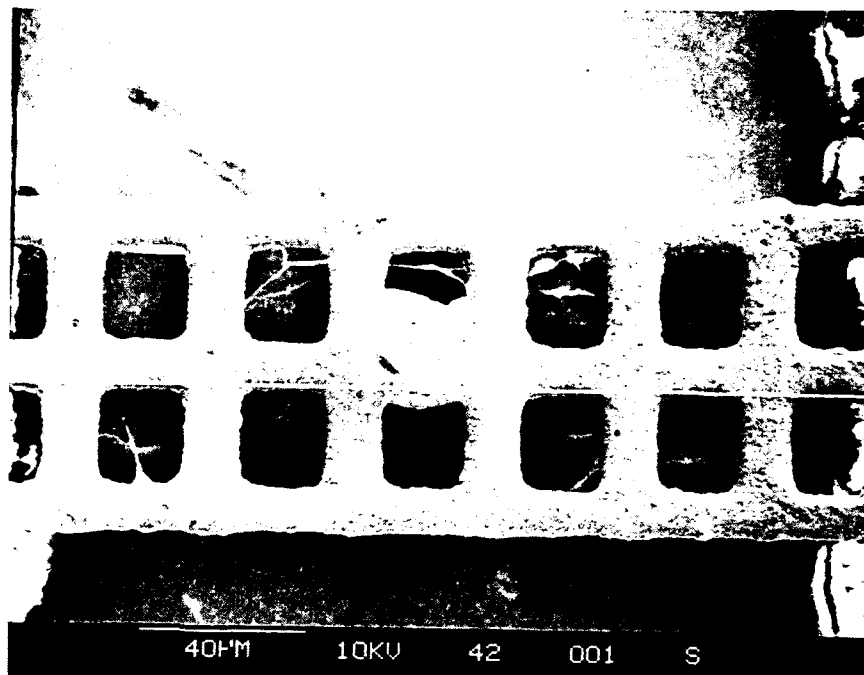
Figure 19a. Stringers of epoxy can be seen in this top view of the ribbon (NASA device, S/N 142, 575× magnification).

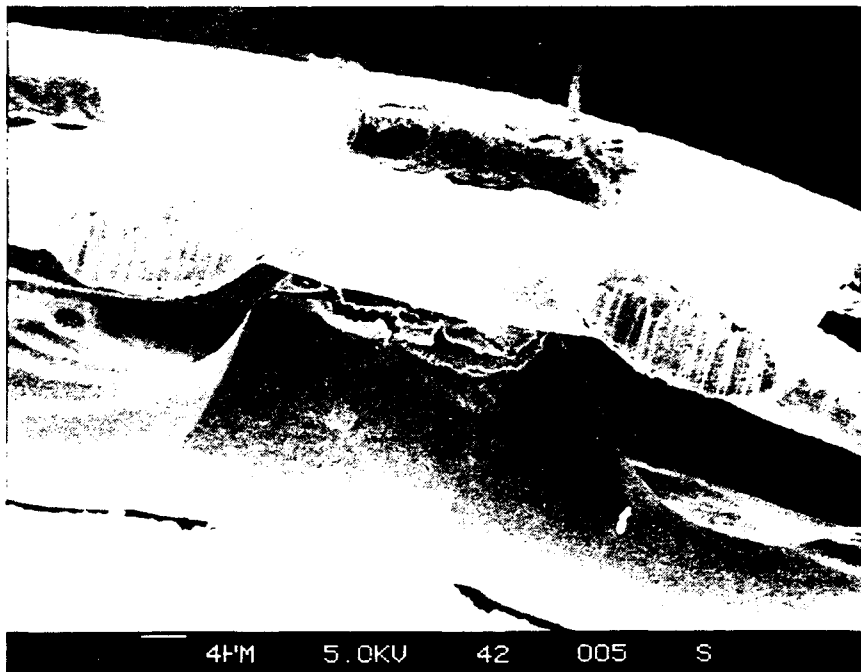
Figure 20b. Mesa region. The Ge has fracture (NASA device, S/N 142, 2000 $\times$  magnification). No "stalk" evident.

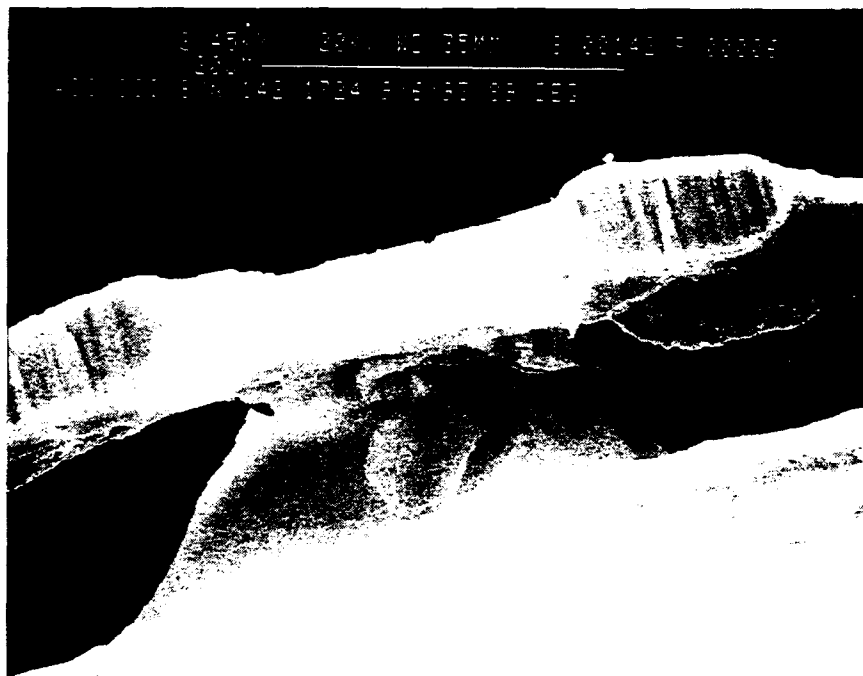
Figure 21b. This is the other side of the "mesa" (see Fig. 20b) (NASA device, S/N 142, 2450 $\times$  magnification). Still no evidence of a "stalk."
